“Material Problems” on the stem side

Michael M Morlock
bmh
 Institute of Biomechanics
 TUHH Hamburg University of Technology

Belgian Hip Society - 25. April 2019

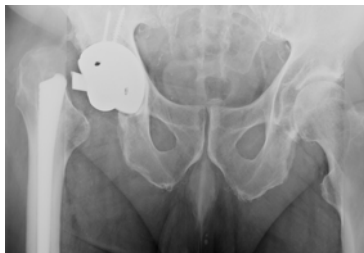
Primary THA: 2006
Pre cup exchange: 2016
Post cup exchange: 2016
Stem fracture: 2017

- High bending load for 10 years (3×XL head)
- Weakening of highly loaded area during revision (scratches, spark transition from electro knife)
- Notch sensitivity of Ti-Alloys

- Don't touch the stem with an electro knife during revision surgery if you want to keep it
- If you try to take the stem out - you have to finish it...

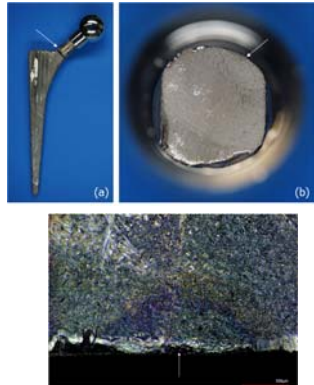
Fracture 15.05.2014

..... the combination of a CLS stem and a DePuy head with a neck length of **more than 8 mm** is an unauthorized combination, which is not released by Zimmer (see www.product-compatibility.zimmer.com)...
...

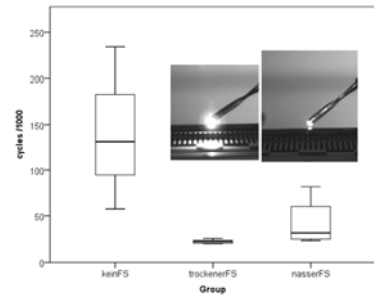
Fatigue testing in cyclic 4 point-bending

- Cyclic bending
- $f = 10 \text{ Hz}$
- Maximum bending stress $S_B = 1640 \text{ MPa}$
 - FEMA $S_{\text{joggingHigh100}} = 694 \text{ MPa}$
 - FEMA $S_{\text{stumble}} = 2277 \text{ MPa}$

Failure for unmodified rods (left), dry contact (middle) and wet contact (right; cycles *1000)

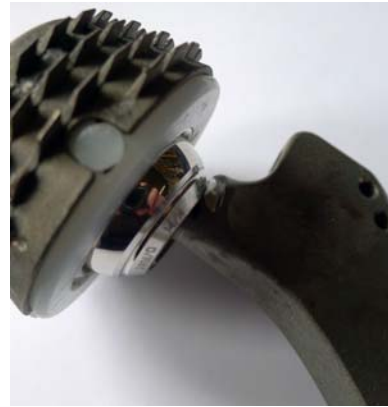
76 y female
16 years in situ
small ø MoM

Mismatch
14/16 head
with a
12/14 stem taper

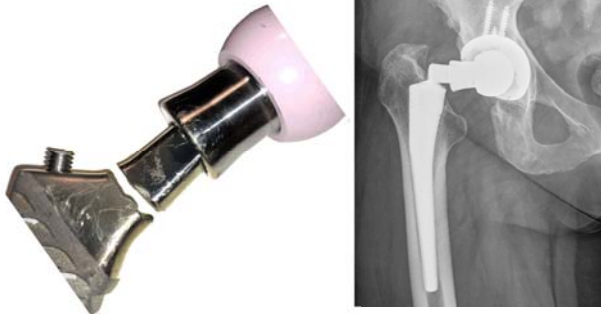
Index Surgery 11/2005 head +8.5mm
 Cup exchange 03/2014 BioBall 4XL, 32mm
 Neck fracture w/o trauma 11/2018

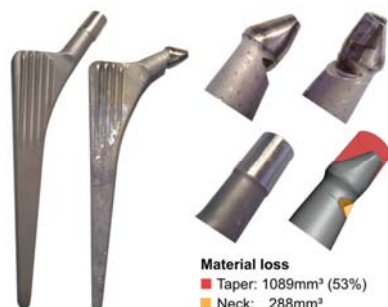
Material loss
 Head: 403mm³

Material loss
■ Taper: 1089mm³ (53%)
■ Neck: 288mm³

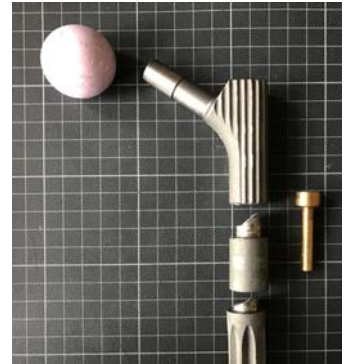
- Double fracture
- Biolox Ø36mm 12/14 XL (+8)
- only+5 approved
